Manhole Inspection Summary

Manhole # S29YY_044MH

Insp Date: **10/9/08 2:12 PM**

Location Address: **GILMAN TER**

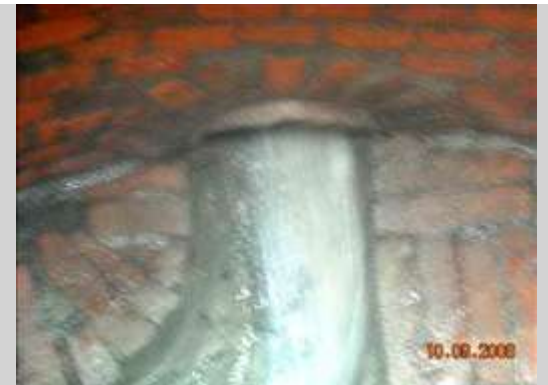
10 in. Circular Gravity Sewer Pipe In @ 3 O'Clock

Invert Depth: **7.95** (ft.) Flow Characteristics: **Fast**

Deposits: ☒ None ☐ Mud ☐ Sludge ☐ Debris ☐ Grease

Infiltration: **None** Pipe Seal Cond: **Unknown**

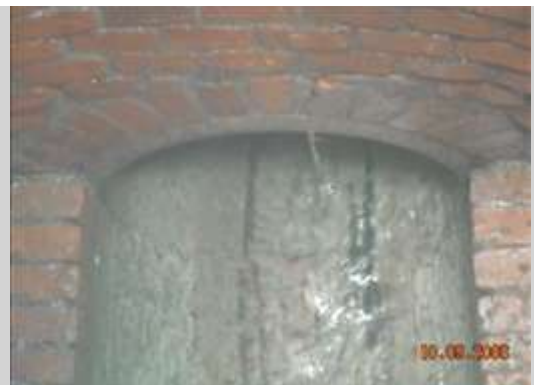
21 in. Circular Gravity Sewer

Pipe Material: **Clay**

Infiltration: **None**
